2014 Water Levels

Table of Contents

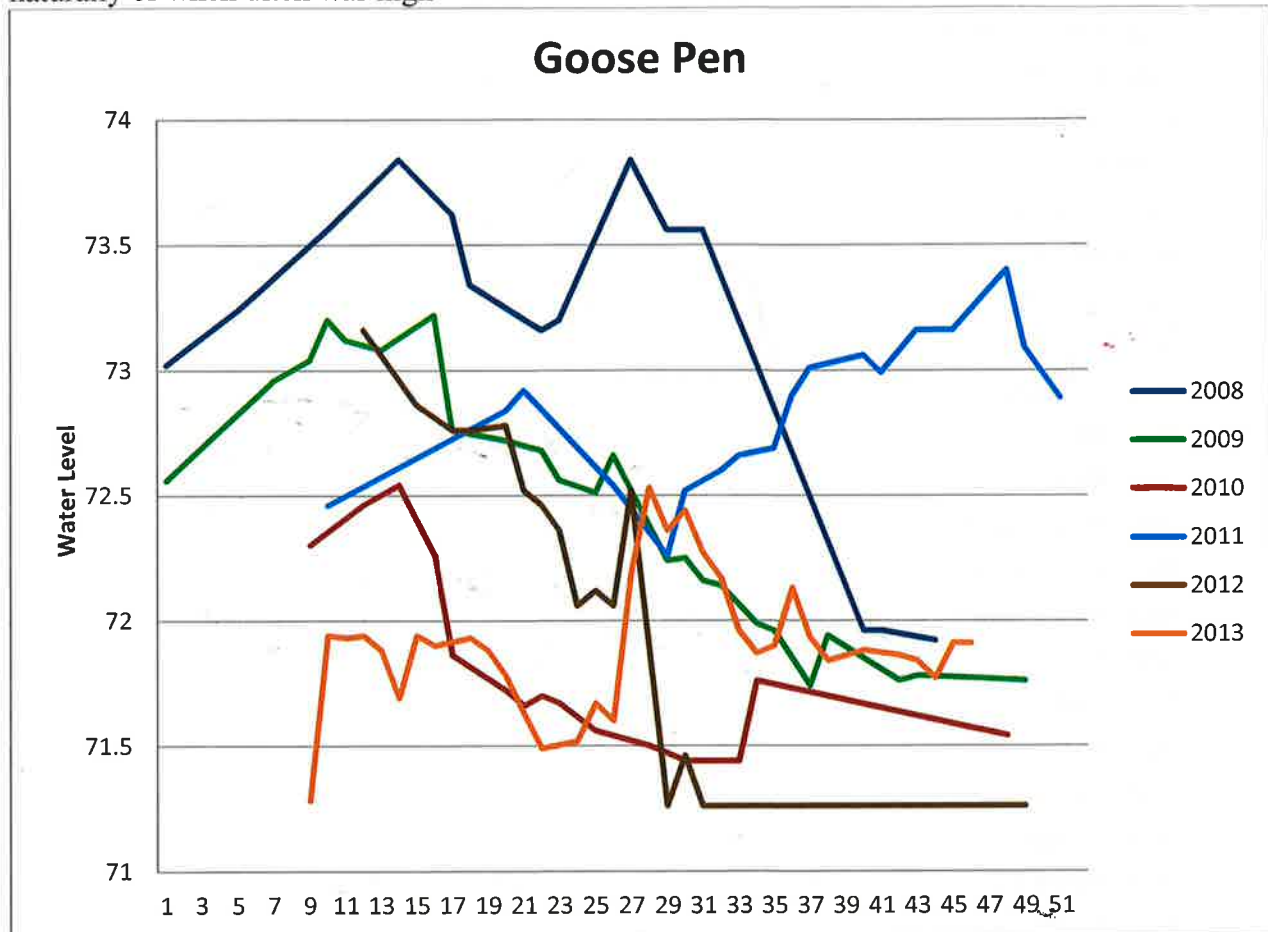
Unit: Goose Pen

Draw Down Years: 2012-drought, 2010- drawn down in April unable to reflood until 2011. 2009 - low water allowed evapotranspiration to expose mudflats on high ground areas in September (0.48); 2006 – March through September draw down. 50% mudflats exposed April 10. Reflooded naturally or when ditch was high in Oct.

Repairs Needed: I. Water control structure failure, pipe suspected. Unit lost water over winter and is near lake average.

II. East dike in bad shape, and portions of west dike. Needs IGLD gauge.

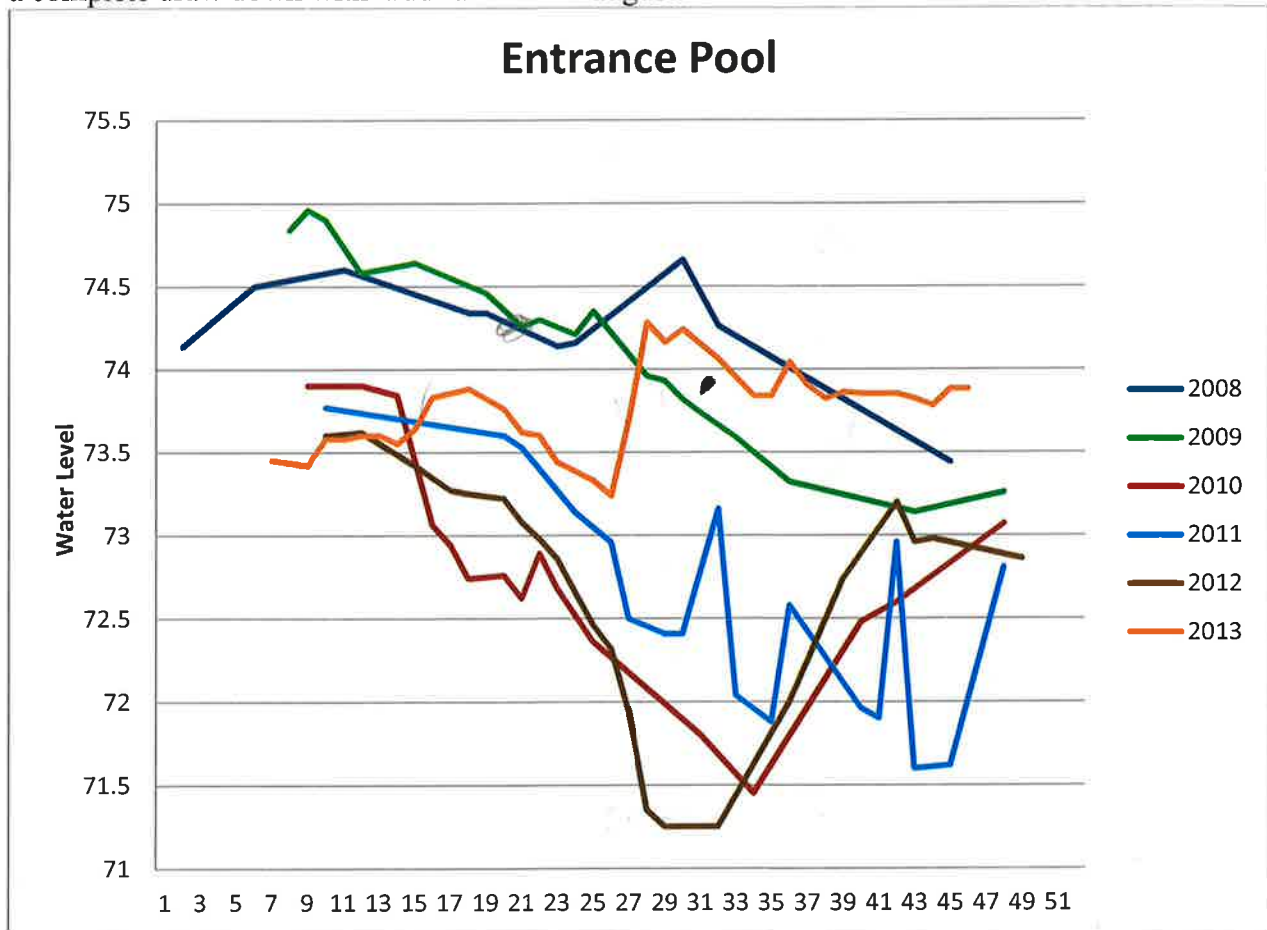
Note: 1.0 (73.16) = water only in channel.

Repairs Needed: Check Boards make sure they are functioning.

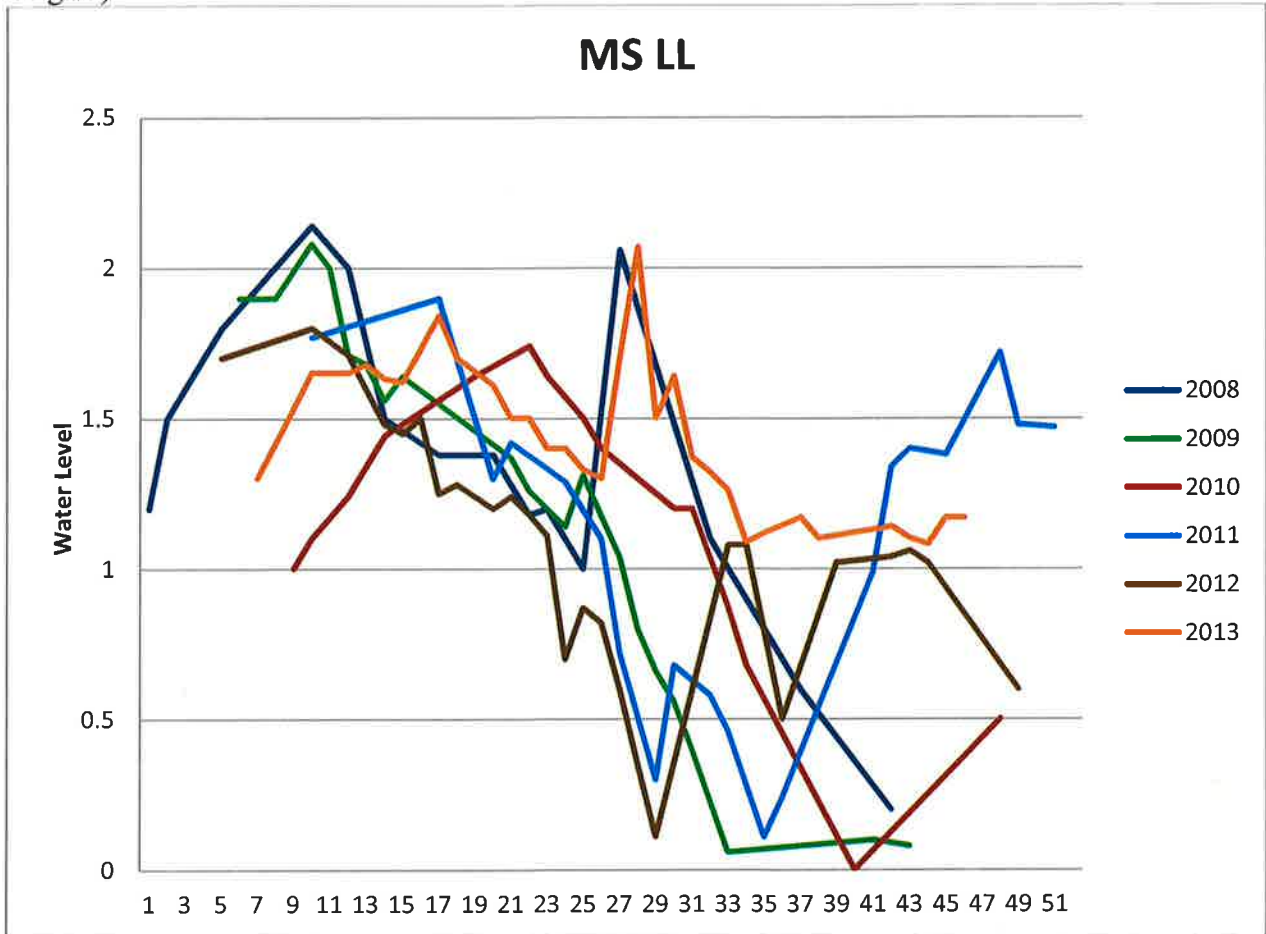
Draw Down Years: 2012-due to drought, 2010- Starting in September water was below boards until December. 2009 – evapotranspiration resulted in late summer draw down (late July and August)

- I. Pipe to WCS is problematic. -current status unknown – works sometimes.
- II. Dike breached to MS 8a is a major repair that should be addressed.
- III. Install IGLD gauge

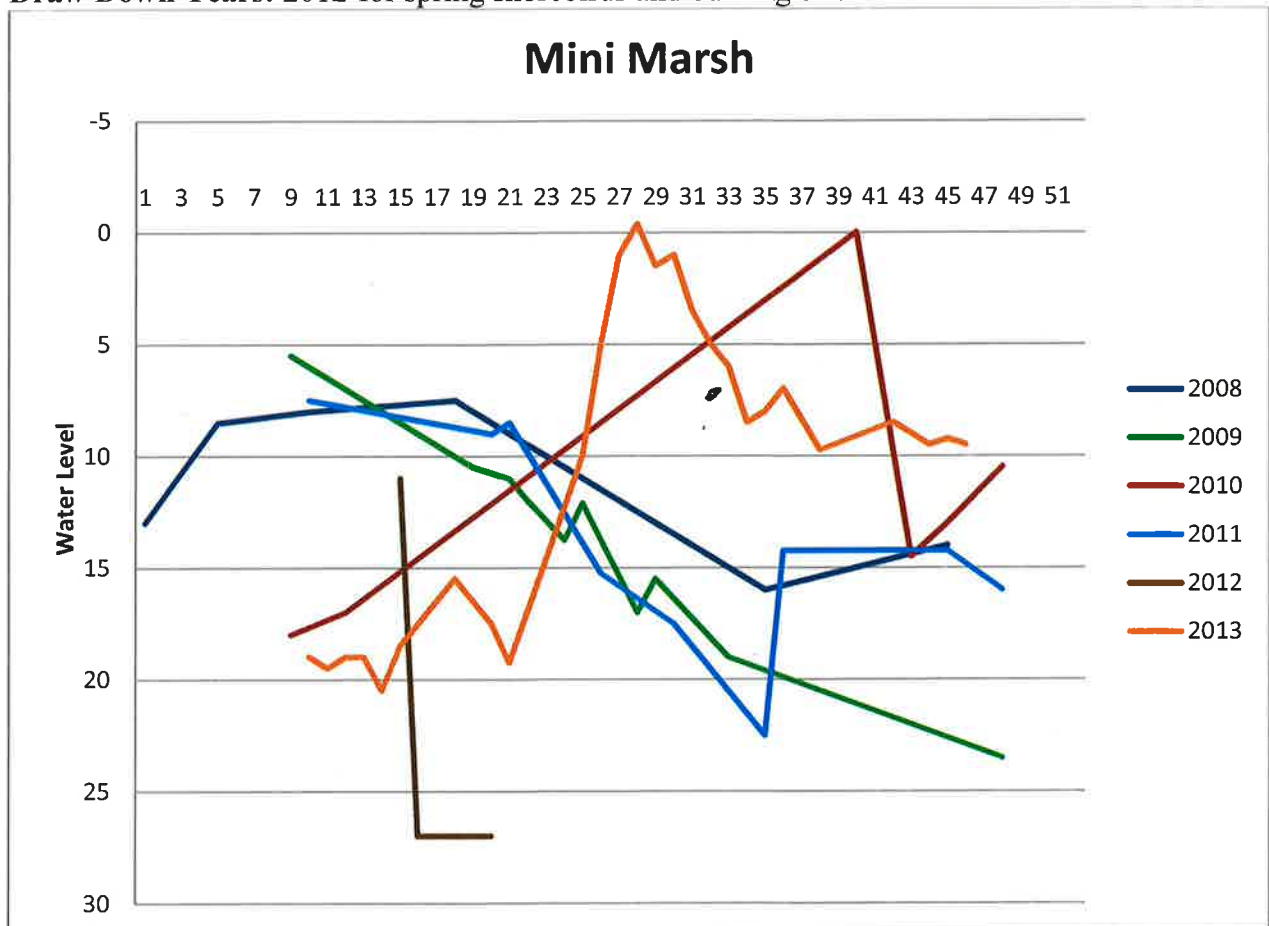
Note: graph scale is inverted; this is a measure down to water surface.

Management Strategy Constraints: If water in unit gets much higher than half way up the side of the discharge pipe, water leaks through splitter box to Crane Creek. Needs new flap gate.

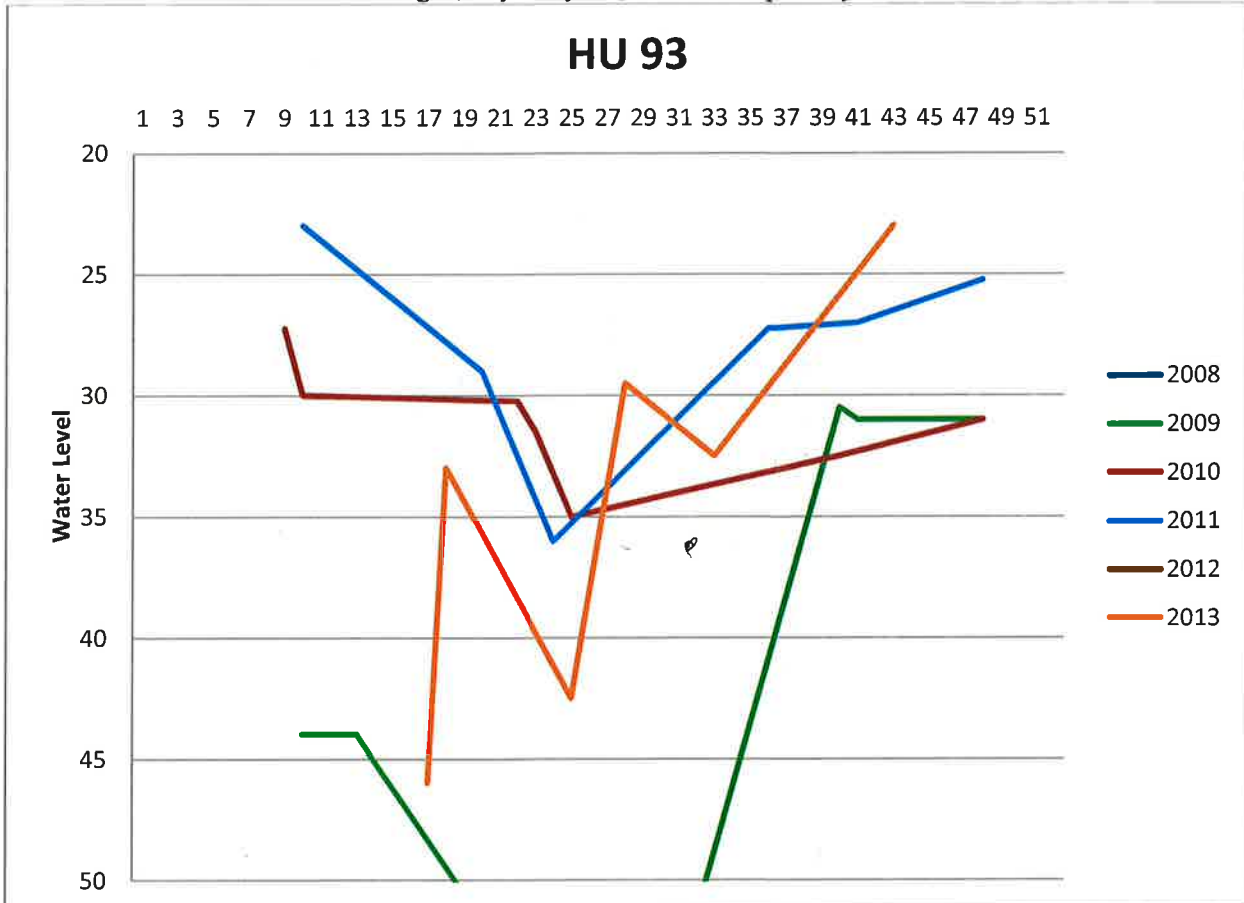
Note: graph scale is inverted; this is a measure down to water surface.

- I. If this unit is maintained as a wetland, then the west and south dikes are in questionable shape & may degrade quickly with water against them year round. Consider rebuilding for better compaction, tile search, & higher dike tops.
- II. Set staff plate

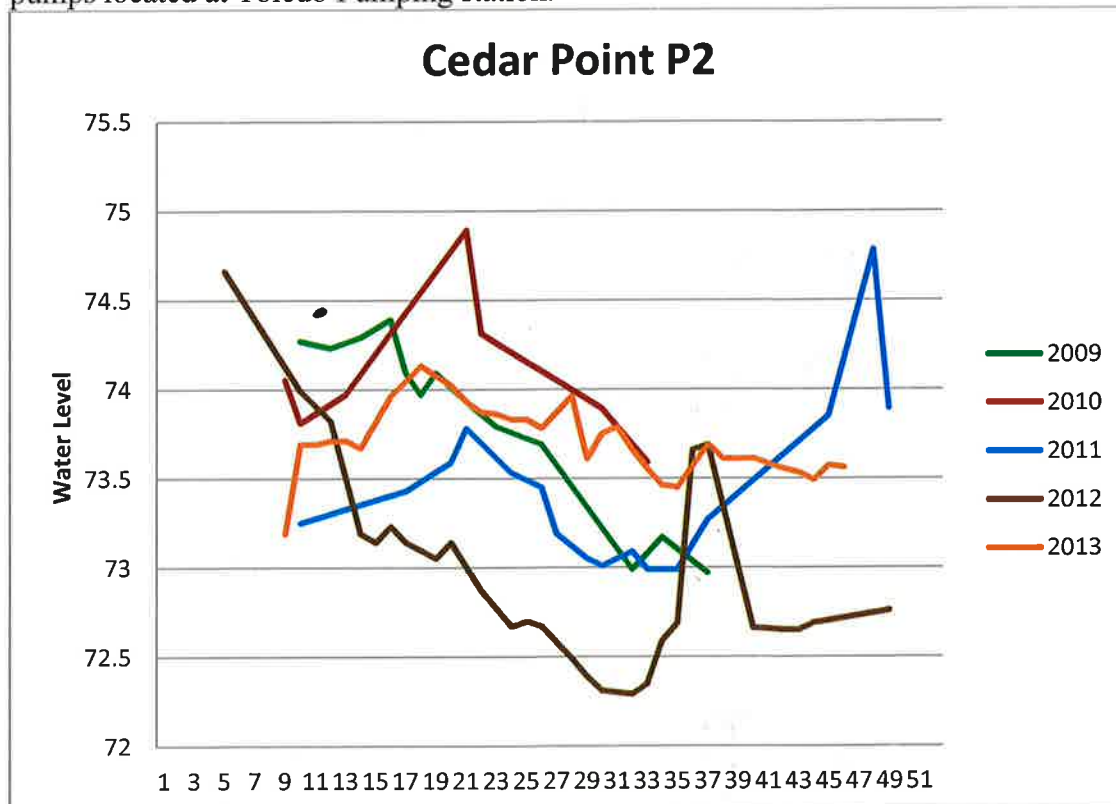
Note: Water readings from gauge in borrow pit do not reflect unit conditions at lower unit levels.
